Field Engineering Bulletin
071828310 October 31, 2007

Trinix Broadlinx 2.4.2 Upgrade

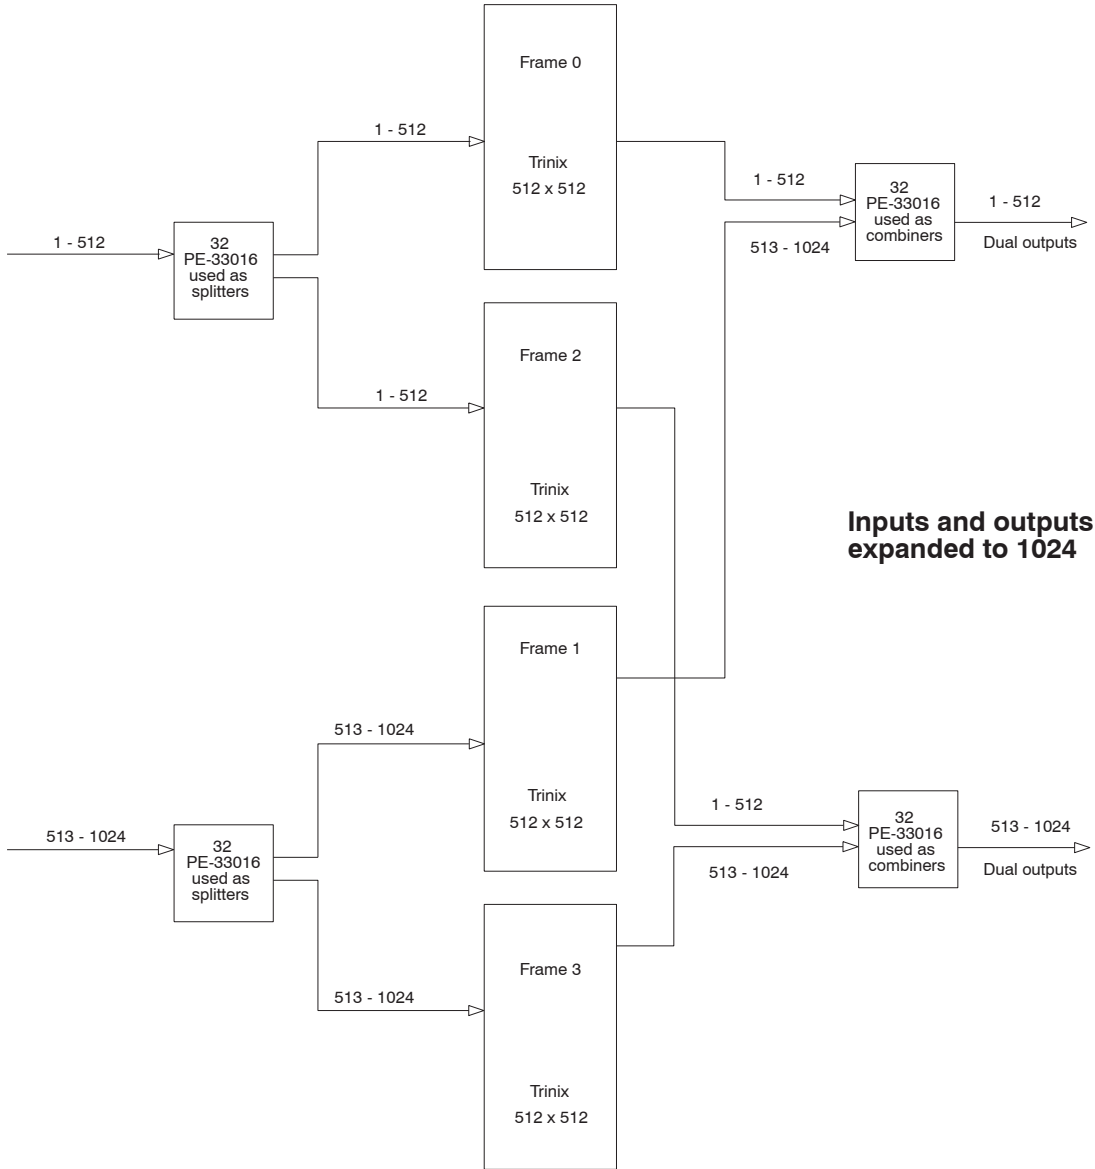
Figure 1. 1024 x 1024 system.

Each of these figures illustrate a series of 512 x 512 chassis in expanded systems, but the frame numbers shown are out of sequence. For example, the figure showing a "1024 x 1024 system" shows frame numbers reading (from top to bottom) "Frame 0," "Frame 1," "Frame 2," and "Frame 3;" whereas the correct sequence is Frame 0, 2, 1, and 3.

Corrected versions of these four figures are included with this document, starting on page 13.
