## XIP-3901-DC

### Release History

## UPGRADE PACKAGE: 1.1.0

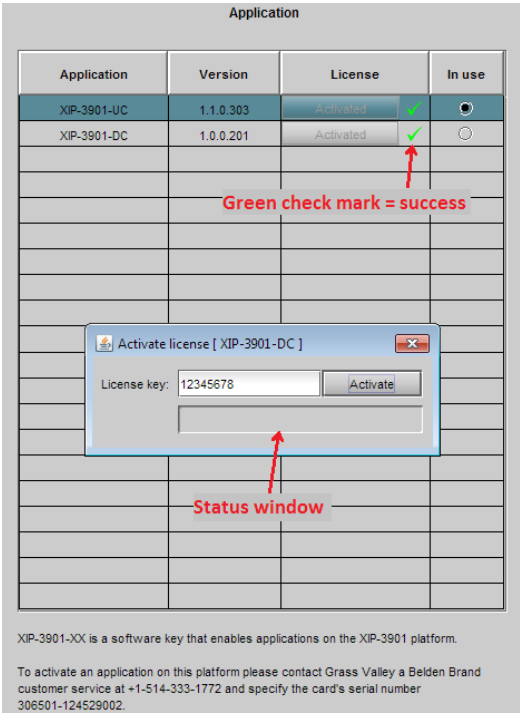
Ref #	Description
<a href="#">XIP3901DC-833</a>	<p><b>Application Manager does not show success after activating a license.</b></p> <p>The Application Manager panel is used to activate or switch between applications. It shows all the applications on the platform, their respective versions, whether their license keys have been activated, and which one is currently in use. It is accessed by clicking the Application button in the iControl XIP-3901-UC control panel.</p> <p>To activate an application, click the Activate button in the License column. In the Activate license dialog box that appears, enter the license key and click Activate. If the key is valid, the status window under the key should become green to indicate success but does not. Yet successful activation of the license is confirmed with the green check mark that now appears in the License column. The dialog box can now be closed. See the following image:</p>
