## XIP-3901-UC

### Release History

## UPGRADE PACKAGE: 2.1.0

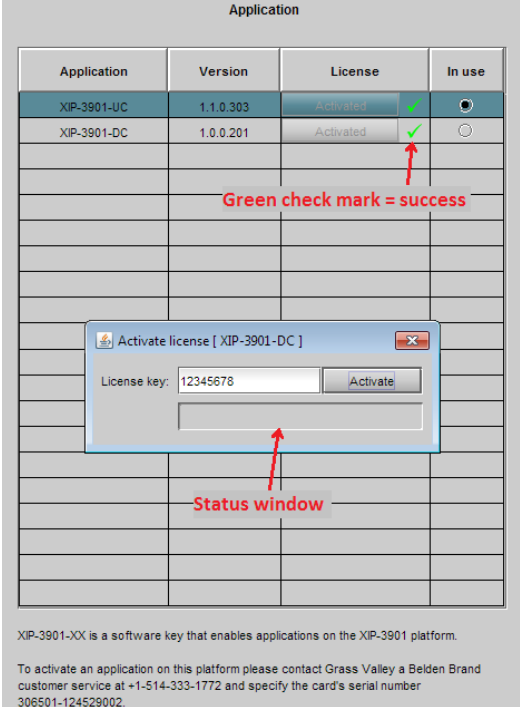
Ref #	Description
XIP3901UC-1021	<p><b>Application Manager does not show success after activating a license.</b></p> <p>The Application Manager panel is used to activate or switch between applications. It shows all the applications on the platform, their respective versions, whether their license keys have been activated, and which one is currently in use. It is accessed by clicking the Application button in the iControl XIP-3901-UC control panel.</p> <p>To activate an application, click the Activate button in the License column. In the Activate license dialog box that appears, enter the license key and click Activate. If the key is valid, the status window under the key should become green to indicate success but does not. Yet successful activation of the license is confirmed with the green check mark that now appears in the License column. The dialog box can now be closed. See the following image:</p>

XIP-3901-XX is a software key that enables applications on the XIP-3901 platform.

To activate an application on this platform please contact Grass Valley a Belden Brand customer service at +1-514-333-1772 and specify the card's serial number 306501-124529002.
