XIP-3901-UC

Release History

UPGRADE PACKAGE: 1.1.0

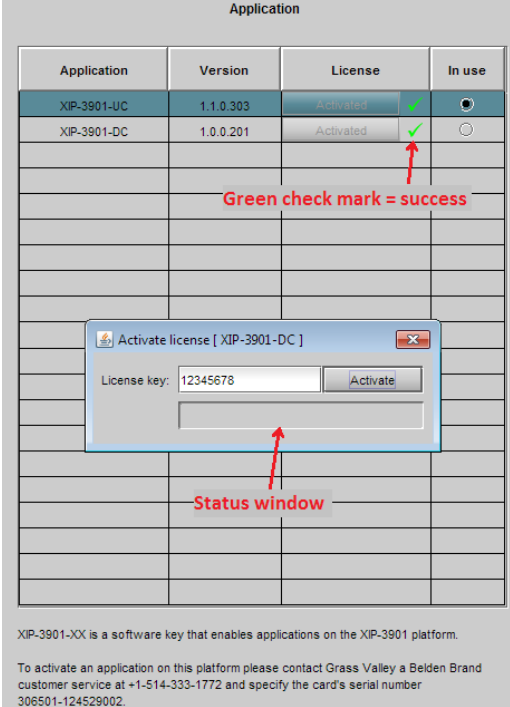
XIP3901UC-1021	<p>Application Manager does not show success after activating a license.</p> <p>The Application Manager panel is used to activate or switch between applications. It shows all the applications on the platform, their respective versions, whether their license keys have been activated, and which one is currently in use. It is accessed by clicking the Application button in the iControl XIP-3901-UC control panel.</p> <p>To activate an application, click the Activate button in the License column. In the Activate license dialog box that appears, enter the license key and click Activate. If the key is valid, the status window under the key should become green to indicate success but does not. Yet successful activation of the license is confirmed with the green check mark that now appears in the License column. The dialog box can now be</p>

closed. See the following image:
