XIP-3901-UC

Release History

UPGRADE PACKAGE: 1.2.0

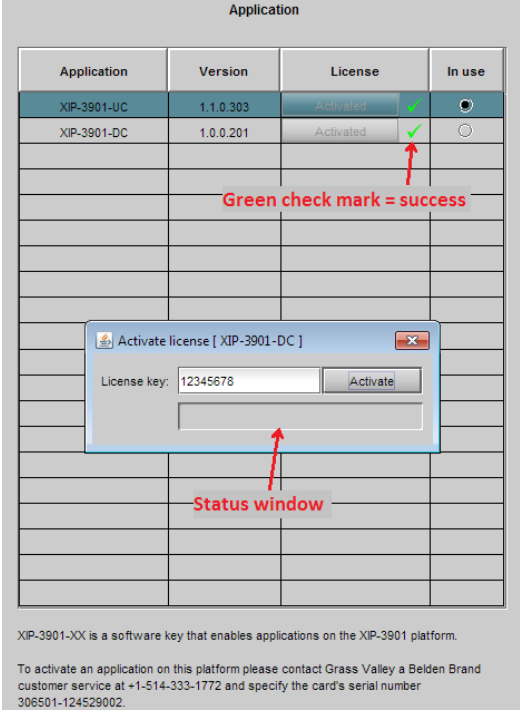
Ref #	Description
XIP3901UC-1021	<p>Application Manager does not show success after activating a license.</p> <p>The Application Manager panel is used to activate or switch between applications. It shows all the applications on the platform, their respective versions, whether their license keys have been activated, and which one is currently in use. It is accessed by clicking the Application button in the iControl XIP-3901-UC control panel.</p> <p>To activate an application, click the Activate button in the License column. In the Activate license dialog box that appears, enter the license key and click Activate. If the key is valid, the status window under the key should become green to indicate success but does not. Yet successful activation of the license is confirmed with the green check mark that now appears in the License column. The dialog box can now be closed. See the following image:</p>

Green check mark = success
