## XIP-3901-UC

### Release History

## UPGRADE PACKAGE: 2.0.0

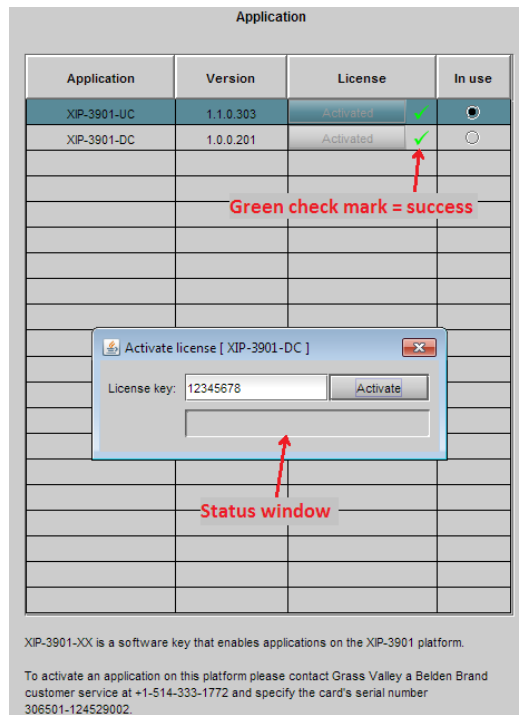
Ref #	Description
XIP3901UC-1021	<p><b>Application Manager does not show success after activating a license.</b></p> <p>The Application Manager panel is used to activate or switch between applications. It shows all the applications on the platform, their respective versions, whether their license keys have been activated, and which one is currently in use. It is accessed by clicking the Application button in the iControl XIP-3901-UC control panel.</p> <p>To activate an application, click the Activate button in the License column. In the Activate license dialog box that appears, enter the license key and click Activate. If the key is valid, the status window under the key should become green to indicate success but does not. Yet successful activation of the license is confirmed with the green check mark that now appears in the License column. The dialog box can now be</p>

closed. See the following image:

Green check mark = success
