Havant IP Core Release Notes

Overview

The following release note covers all of the products manufactured for the Havant IP Core.

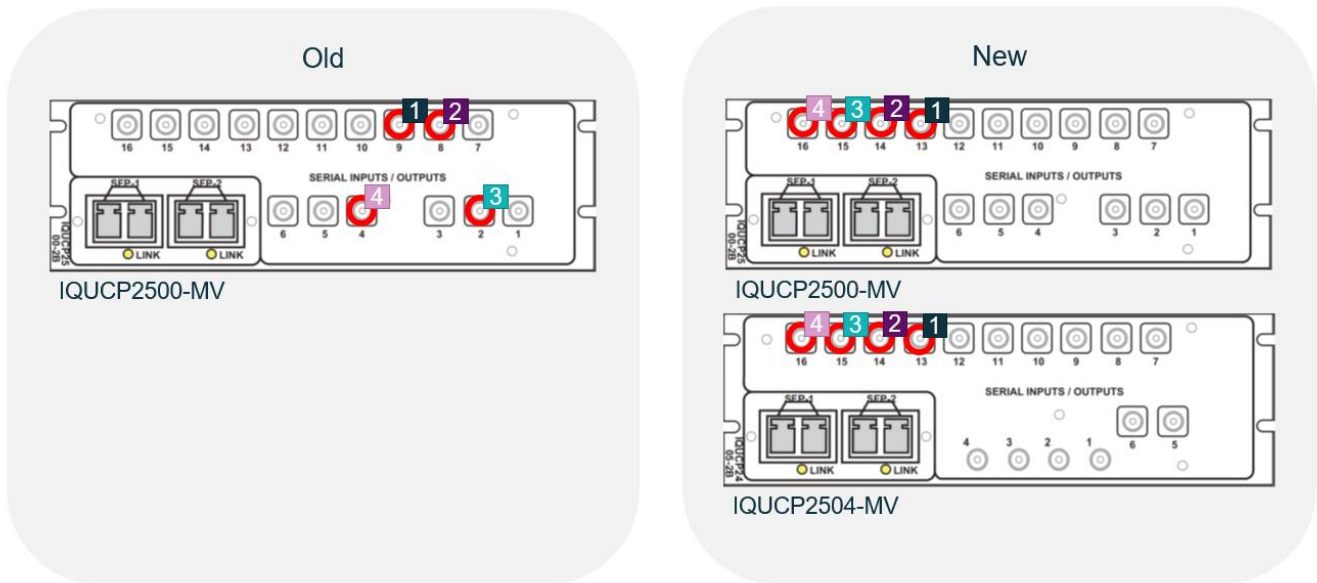
V16.0 also sees the remapping of the IQUCPxx-MV BNCs as detailed below.
