# Havant IP Core Release Notes

The following release note covers all of the products manufactured for the Havant IP Core.

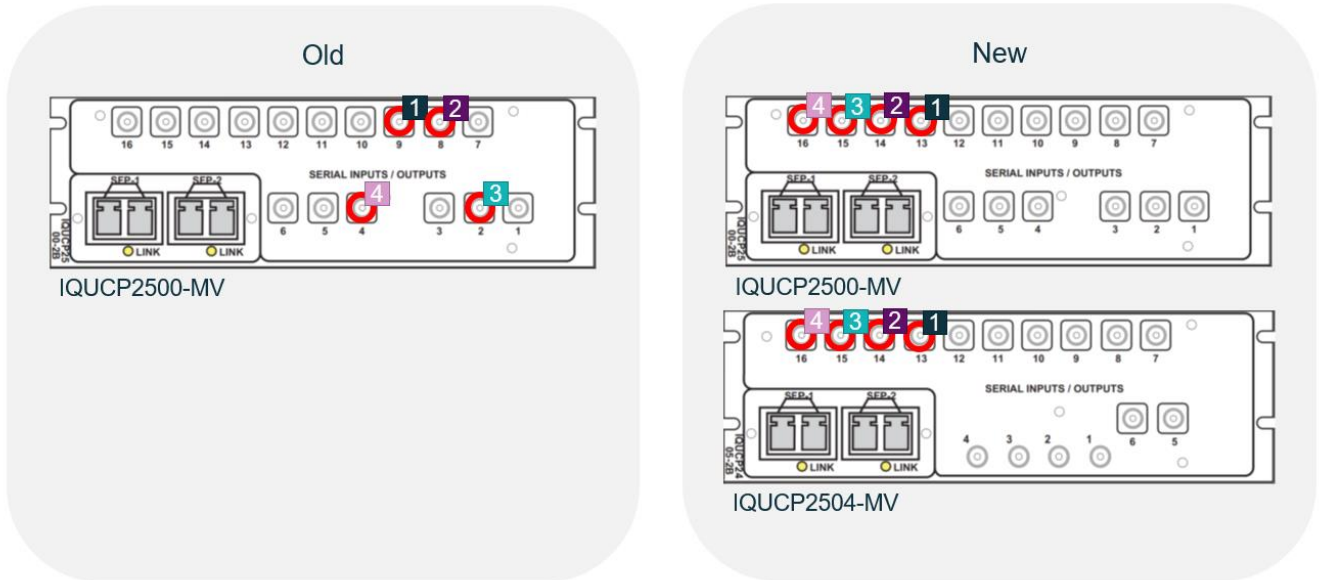
V16.0 also sees the remapping of the IQUCPxx-MV BNCs as detailed below.
