KALEIDO SOFTWARE

Version 9.21

Release Notes

M770-2103-186

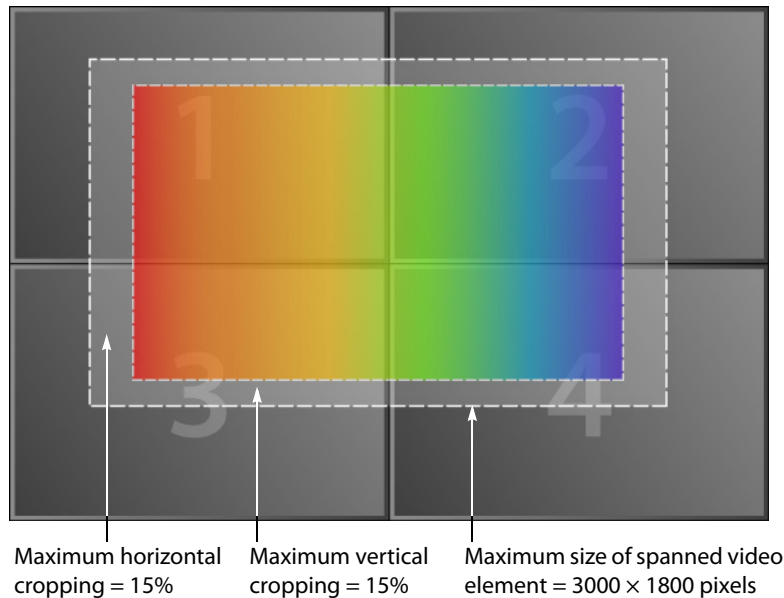
- [Ref. #KX-2270] **Kaleido-X, Kaleido-X16:** excessive scaling of video elements results in a loss of video image on a monitor wall. This can be caused by loading a complex layout with a video monitor or full screen zone spanning two or more displays. The problem can be made worse by overlapping elements.
Workaround: Keep full screen zones within a single display. Do not span a monitor beyond a maximum of 3000 × 1800 pixels. When spanning or scaling video monitors in a layout, avoid heavy cropping settings (generally avoid exceeding 15% in any direction). If the problem persists in full screen layouts, try reducing the scaling settings further.

Note: Even if a spanned video monitor does not exceed the recommended maximum size, the problem could occur if it is set to follow AFD/WSS with a custom cropping of (15, 15, 15, 15).
