KALEIDO SOFTWARE

Version 10.20

Release Notes

M770-2103-192

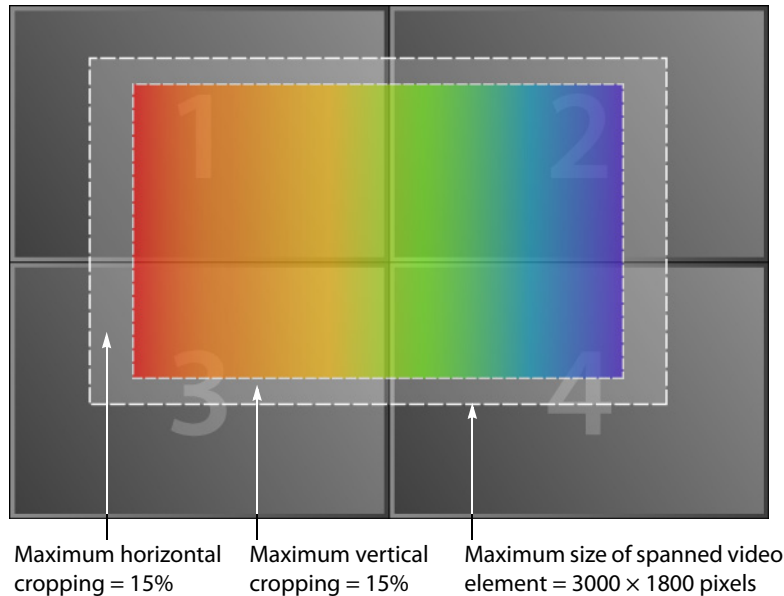
- [Ref. #KX-2270] **Kaleido-X, Kaleido-X16:** excessive scaling of video elements results in a loss of video image on a monitor wall. This can be caused by loading a complex layout with a video monitor or full screen zone spanning two or more displays. The problem can be made worse by overlapping elements.

Workaround: Keep full screen zones within a single display. Do not span a monitor beyond a maximum of 3000 × 1800 pixels. When spanning or scaling video monitors in a layout, avoid heavy cropping settings (generally avoid exceeding 15% in any direction). If the problem persists in full screen layouts, try reducing the scaling settings further.
