KALEIDO SOFTWARE

Version 10.23

Release Notes

M770-2103-195

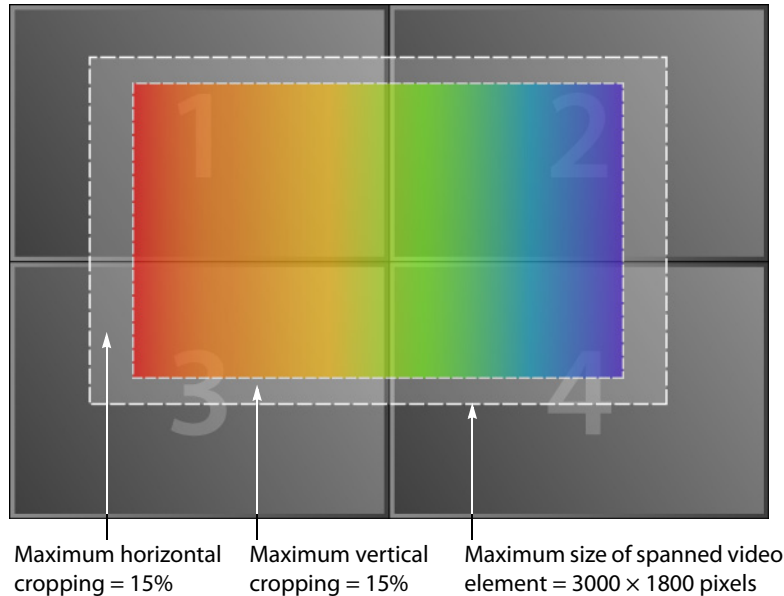
- [Ref. #KX-2270] **Kaleido-X, Kaleido-X16:** excessive scaling of video elements results in a loss of video image on a monitor wall. This can be caused by loading a complex layout with a video monitor or full screen zone spanning two or more displays. The problem can be made worse by overlapping elements.

Workaround: Keep full screen zones within a single display. Do not span a monitor beyond a maximum of 3000 × 1800 pixels. When spanning or scaling video monitors in a layout, avoid heavy cropping settings (generally avoid exceeding 15% in any direction). If the problem persists in full screen layouts, try reducing the scaling settings further.

Note: Even if a spanned video monitor does not exceed the recommended maximum size, the problem could occur if it is set to follow AFD/WSS with a custom cropping of (15, 15, 15, 15).
