# ***KALEIDO SOFTWARE***

Version 10.24

## **Release Notes**

M770-2103-196

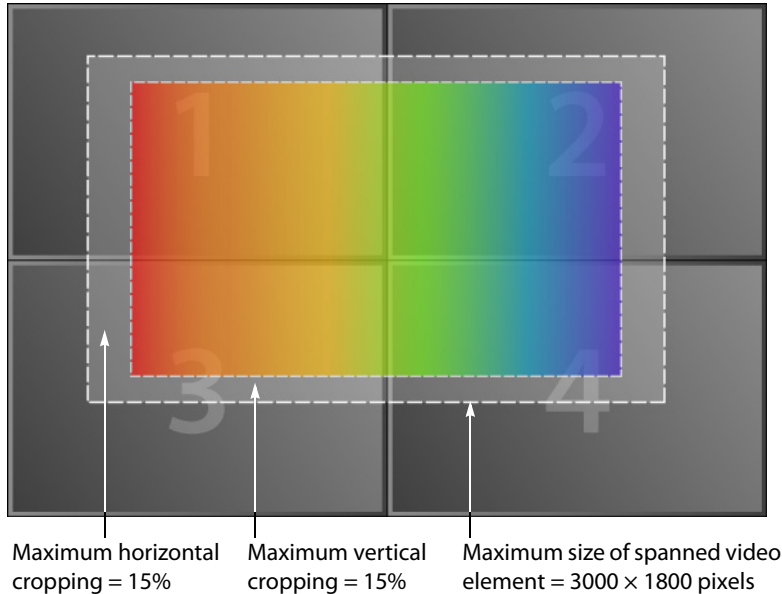
- [Ref. #KX-2270] **Kaleido-X, Kaleido-X16:** excessive scaling of video elements results in a loss of video image on a monitor wall. This can be caused by loading a complex layout with a video monitor or full screen zone spanning two or more displays. The problem can be made worse by overlapping elements.

**Note:** Even if a spanned video monitor does not exceed the recommended maximum size, the problem could occur if it is set to follow AFD/WSS with a custom cropping of (15, 15, 15, 15).

*Workaround:* Keep full screen zones within a single display. Do not span a monitor beyond a maximum of 3000 × 1800 pixels. When spanning or scaling video monitors in a layout, avoid heavy cropping settings (generally avoid exceeding 15% in any direction). If the problem persists in full screen layouts, try reducing the scaling settings further.
