KALEIDO SOFTWARE

Version 10.25

Release Notes

M770-2103-197

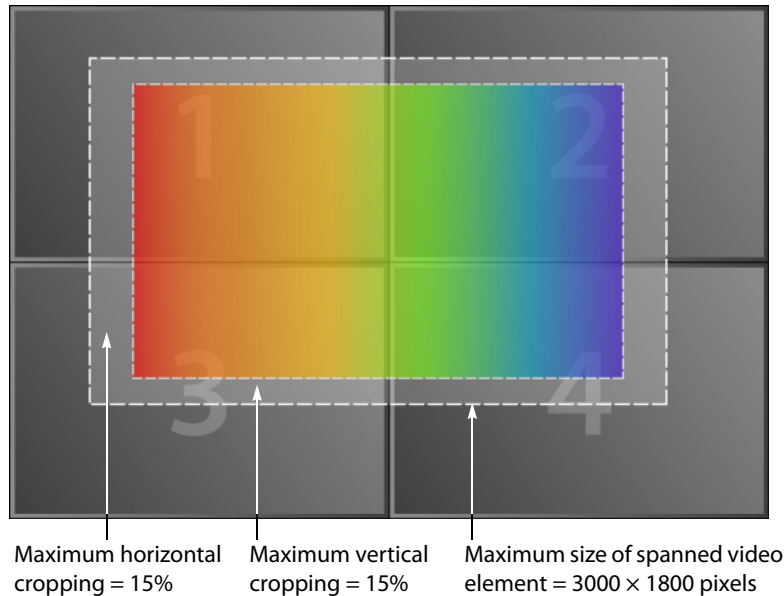
- [Ref. #KX-2270] **Kaleido-X, Kaleido-X16:** excessive scaling of video elements results in a loss of video image on a monitor wall. This can be caused by loading a complex layout with a video monitor or full screen zone spanning two or more displays. The problem can be made worse by overlapping elements.
Workaround: Keep full screen zones within a single display. Do not span a monitor beyond a maximum of 3000 × 1800 pixels. When spanning or scaling video monitors in a layout, avoid heavy cropping settings (generally avoid exceeding 15% in any direction). If the problem persists in full screen layouts, try reducing the scaling settings further.

Note: Even if a spanned video monitor does not exceed the recommended maximum size, the problem could occur if it is set to follow AFD/WSS with a custom cropping of (15, 15, 15, 15).
