# **KALEIDO SOFTWARE**

VERSION 10.28

## **Release Notes**

M770-2103-209

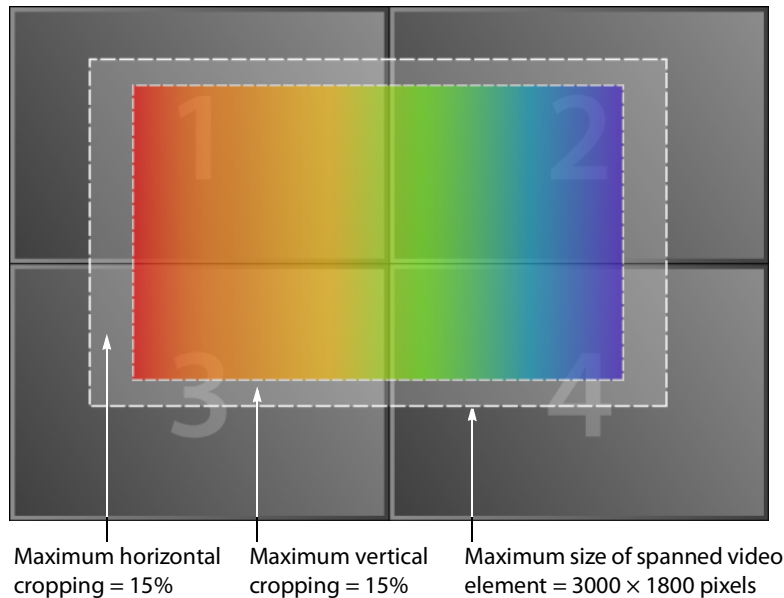
- [Ref. #KX-2270] **Kaleido-X, Kaleido-X16:** excessive scaling of video elements results in a loss of video image on a monitor wall. This can be caused by loading a complex layout with a video monitor or full screen zone spanning two or more displays. The problem can be made worse by overlapping elements.

*Workaround:* Keep full screen zones within a single display. Do not span a monitor beyond a maximum of 3000 × 1800 pixels. When spanning or scaling video monitors in a layout, avoid heavy cropping settings (generally avoid exceeding 15% in any direction). If the problem persists in full screen layouts, try reducing the scaling settings further.
