Field Engineering Bulletin
071828310 October 31, 2007

Trinix Broadlinx 2.4.2 Upgrade

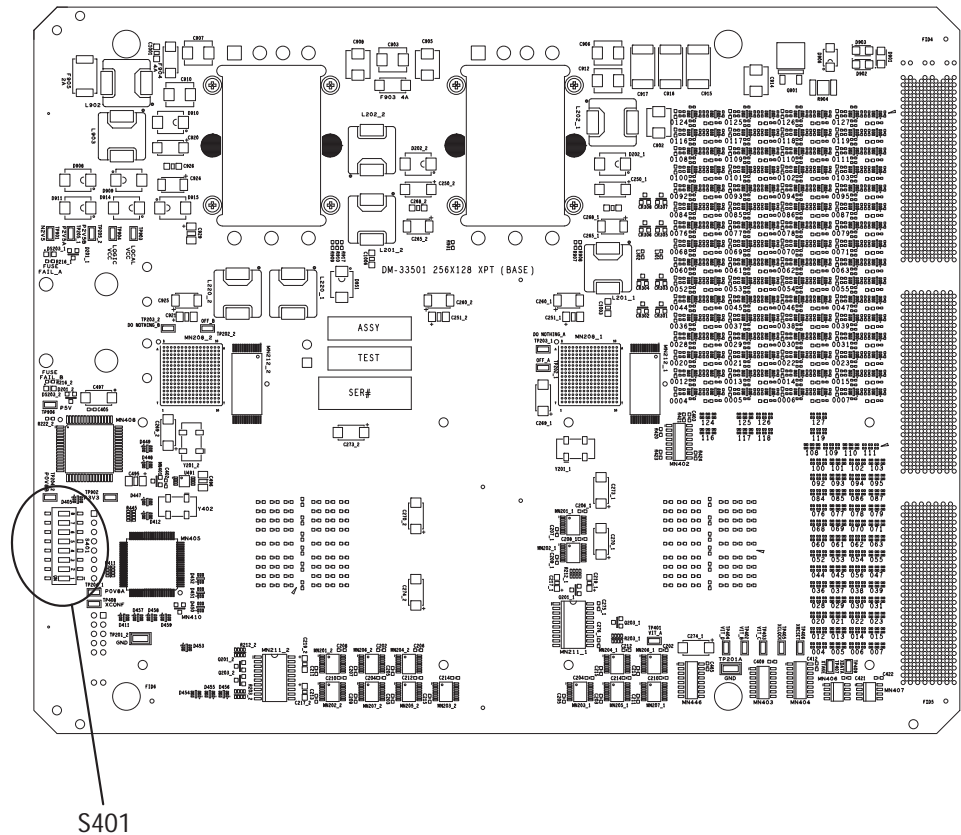
Figure 5. DM-33501 Digital Matrix board. DM--33502 is similar

Recent versions of the DM-33512 Digital Matrix boards used in DV-33512 routers have additional input equalization for improved HD performance; these boards are identified with “Preemphasis Added” stickers on the J421 headers used to connect the two halves of the board. If these stickers are present, and you are upgrading to Broadlinx 2.4 or newer, DIP switches S401-7 and S401-8 (on both boards) should be set to “On;” if the stickers are not present, these switches should be set to “Off.” The remaining six switches on S401 are always set to “Off.” See Figure 5.
