Field Engineering Bulletin
071 8283 01 | March 4, 2004
Reference ECO: 444K

Broadlinx 2.1.1 Upgrade

This release applies to all Trinix routers equipped with a Broadlinx board (NR-33000).

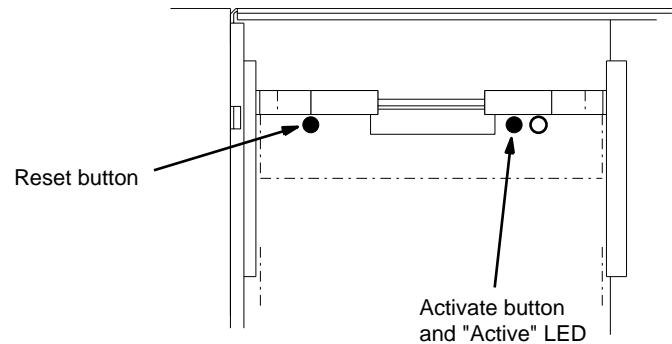
Figure 1. NR-33000 Broadlinx board (as positioned in DV-33512 chassis)

2. If there are two NR-33000 boards present, you must be able to identify which is active. (The firmware update process **MUST** be performed through the **ACTIVE** NR-33000 card, because it has control of the Trinix "Com" bus.) This can be done either by checking the "Active" LED on the NR or by using the "boardShow" console command.
 - a. The Active LED indicator, which is amber, is located next to the Activate push button. See [Figure 1](#).

Jupiter- and **Encore-**controlled systems - press the “Activate” button (see [Figure 1](#)). The “Active” LED indication will switch to this board. Note that a Secondary (amber) alarm will be asserted when the Secondary NR is active. The above mentioned “board-Show” console command can also be used to check active/inactive status.

...entering the quotation marks as shown. Or, press the “Reset” button on the **active** NR-33000 (see [Figure 1](#)). The “Active” LED indication will switch to the opposite board. The above mentioned “boardShow” console command can also be used to check active/inactive status.

- a. **Jupiter-** and **Encore-**controlled systems - press the "Activate" button (see [Figure 1](#)). The "Active" LED indication will switch to this board. Note that a Secondary (amber) alarm will be asserted when the Secondary NR is active. The previously mentioned "boardShow" console command can also be used to check active/inactive status.

...with the quote marks as shown. Or, press the "Reset" button on the **active** NR-33000 (see [Figure 1](#)). The "Active" LED indication will switch to the opposite board. The previously mentioned "boardShow" console command can also be used to check active/inactive status.

2. Make the inactive NR-33000 active:
 - a. **Jupiter-** and **Encore-**controlled systems - press the “Activate” button (see [Figure 1](#)). The “Active” LED indication will switch to this board. Note that a Secondary (amber) alarm will be asserted when the Secondary NR is active. The previously mentioned “boardShow” console command can also be used to check active/inactive status.
 - b. **SMS 7000-**controlled system - use the SMS console command:

...with the quote marks as shown. Or, press the “Reset” button on the **active** NR-33000 (see [Figure 1](#)). The “Active” LED indication will switch to the opposite board. The previously mentioned “boardShow” console command can also be used to check active/inactive status.

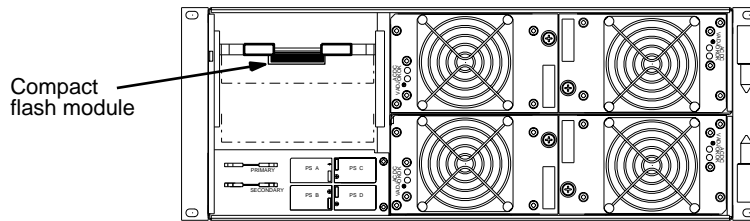
Figure 2. Primary Broadlinx location (DV-33512 installation shown).

- a. Pull out the Broadlinx board (the inactive board if there are two NRs) far enough so the ejector levers allow access to the compact flash module. See [Figure 2](#).

- b. Remove the old flash module by pressing on the adjacent small square ejector button.
- c. Insert the new flash module and seat it firmly.

- d. Re-seat the Broadlinx board. The board will boot up automatically with the new software.

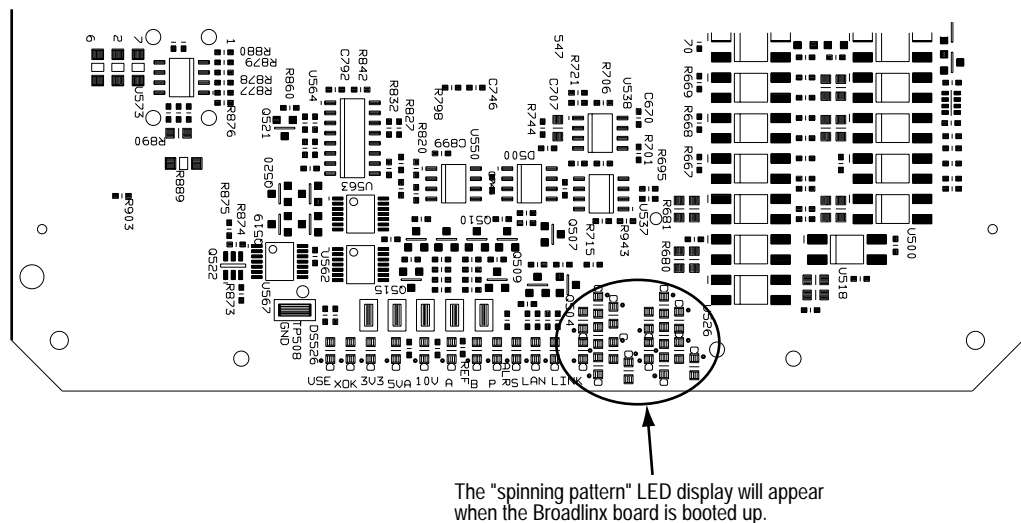
Figure 3. Broadlinx board LEDs.

The boot process will take about 45 seconds, after which you will see a “spinning” pattern of the LEDs on the front edge of the board. See [Figure 3](#).
