*Field Engineering Bulletin*  
071 8283 02 | July 20, 2004  
Reference ECO: 635K

## ***Broadlinx 2.1.1 to 2.2.0 Upgrade***

This release applies only to Trinx routers equipped with a Broadlinx board (NR-33000) operating with software version 2.1.1.

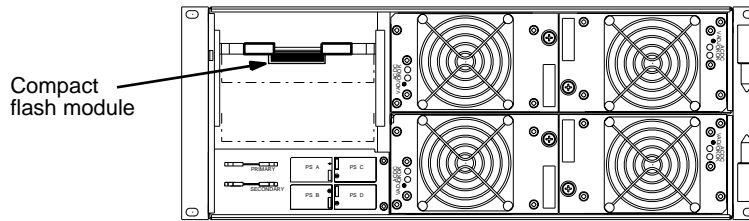
Figure 1. Primary Broadlinx location (DV-33512 installation shown).

1. Install the provided compact flash memory module(s) in the NR-33000 memory slot(s):
  - a. Pull out the Broadlinx board (the inactive board if there are two NRs) far enough so the ejector levers allow access to the compact flash module. See [Figure 1](#) and [Figure 2](#).

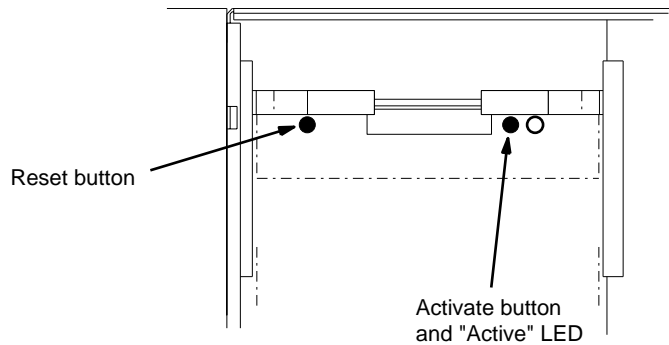
Figure 2. NR-33000 reset/activation controls.

- e. If there are two NR boards, make the inactive NR-33000 active:
  - Jupiter-** and **Encore-**controlled systems - press the “Activate” button (see [Figure 2](#)). The “Active” LED indication will switch to this board. Note that a Secondary (amber) alarm will be asserted when the Secondary NR is active.
  - SMS 7000-**controlled system - press the “Reset” button on the **active** NR-33000 (see [Figure 2](#)). The “Active” LED indication will switch to the opposite board.
- f. If there are two NR boards, return to [Step a](#) above and install the new compact flash memory module on the remaining NR-33000.
