Field Engineering Bulletin
071 8283 03 | February 12, 2005
Reference ECO: 330L

Broadlinx 2.2.1 Upgrade

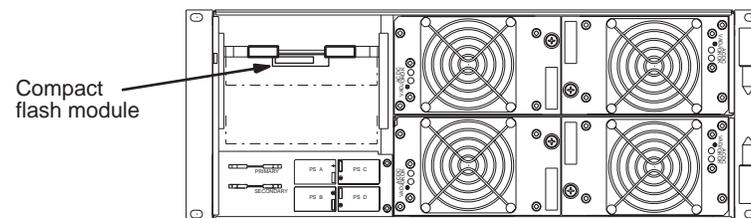
Figure 1. Primary Broadlinx location (DV-33512 installation shown).

1. Install the provided compact flash memory module(s) in the NR-33000 memory slot(s) as follows:
 - a. If there are two NR-33000 boards, locate the inactive board. See Figure 1 and Figure 2.

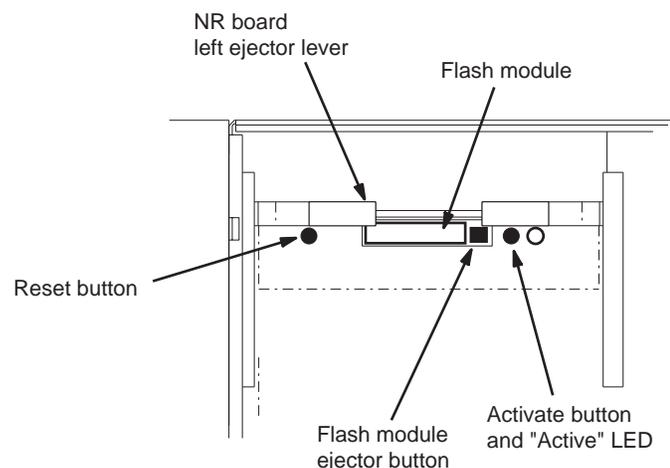
Figure 2. NR-33000 reset/activation controls.

Jupiter- and **Encore-**controlled systems - press the “Activate” button (see Figure 2). The “Active” LED indication will switch to this board. Note that a Secondary (amber) alarm will be asserted when the Secondary NR is active.

SMS 7000-controlled system - press the “Reset” button on the **active** NR-33000 (see Figure 2). The “Active” LED indication will switch to the opposite board.

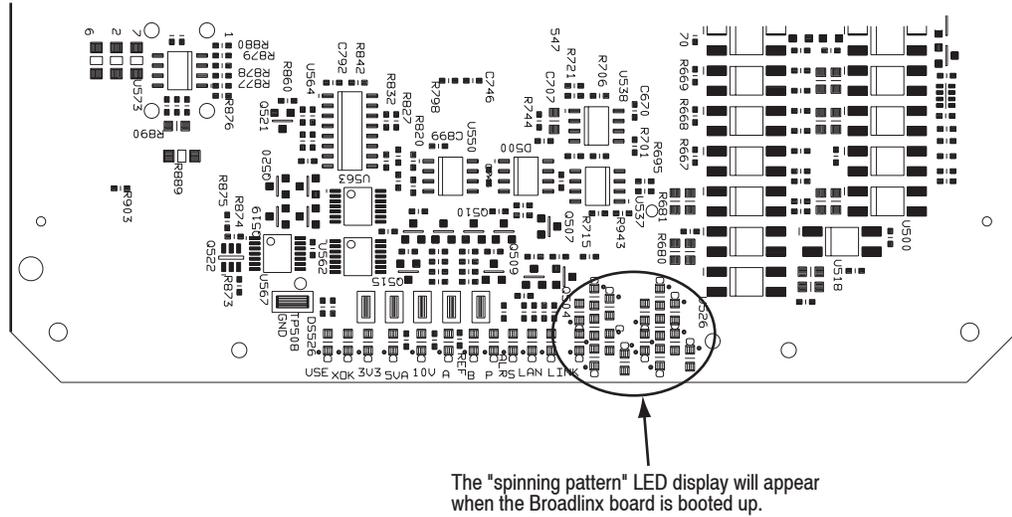
Figure 3. Broadlinx board LEDs.

The boot process will take about 45 seconds, after which you will see a “spinning” pattern of the LEDs on the front edge of the board. See Figure 3.

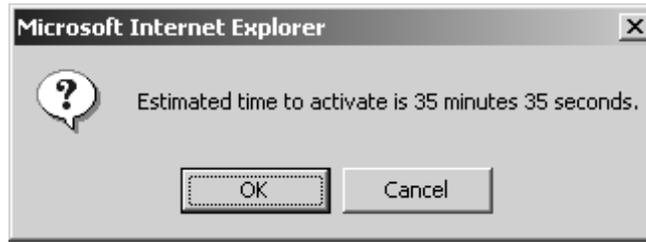
Figure 5.

2. Select "Activate." An "Estimated Time" display will appear:

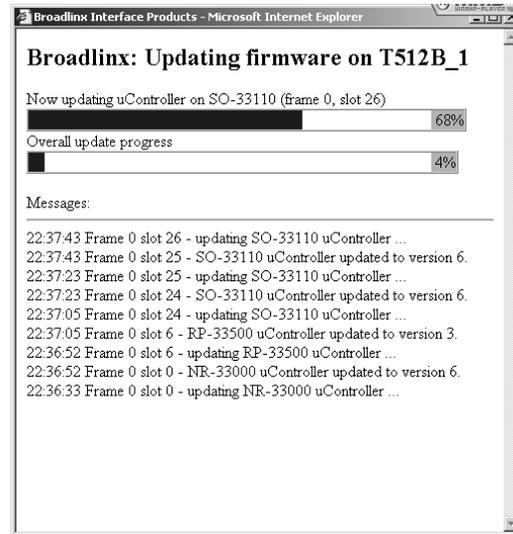
Figure 6.

3. Select "OK." A status window will appear:

The new software will be copied from the NR-33000 to each board that requires update.* This process can take from several minutes to a half hour or more. Progress will be shown by the progress bars and by alarm LEDs on the boards themselves.

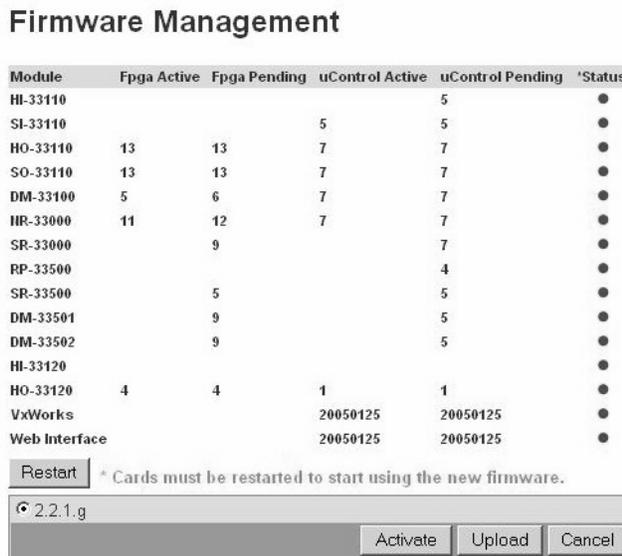
Figure 8.

- Select "Back" to return to the Firmware Management menu. A "Restart" button will now appear near the bottom of the display. (The display may vary from that shown.)

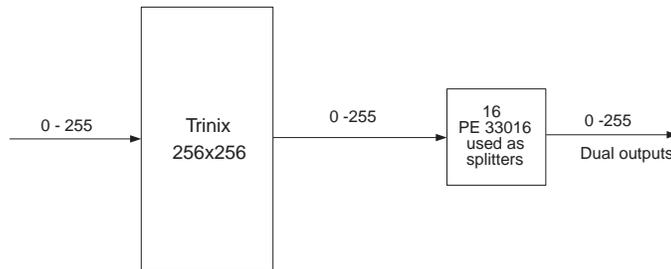
Figure 12.

- 1. Output duplication** (dual/quad outputs) requires output splitters and output gain increase. See Figure 12 for an example.

The necessary gain increase is accomplished by

- Closing the rear-panel *Input Expand* DIP switch, and
- Setting the output board jumpers (or DIP switches) to the “Expand Enable” position (as shown on page 18 and page 19).

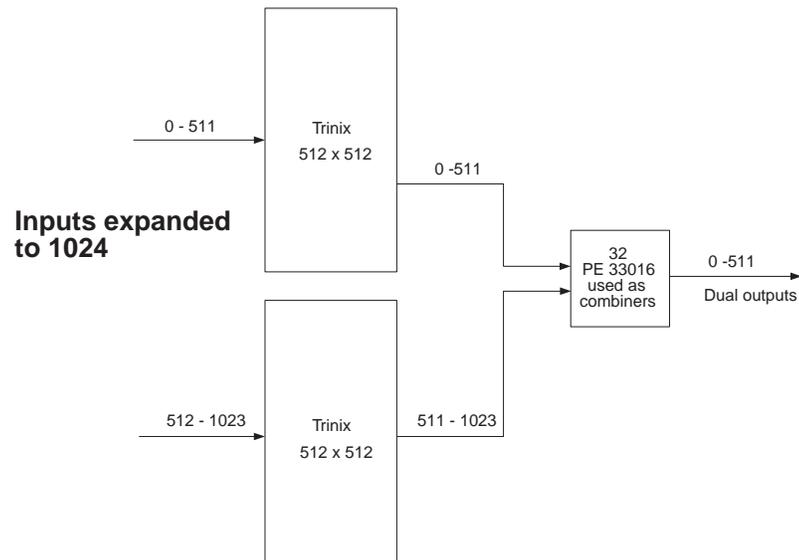
Figure 13.

- 2. Input expansion** requires *output* combiners and *output* gain increase. See Figure 13 for an example.

The necessary gain increase is accomplished by

- Closing the rear-panel *Input Expand* DIP switch, and
- Setting the output board jumpers (or DIP switches) to the “Expand Enable” position (as shown on page 18 and page 19).

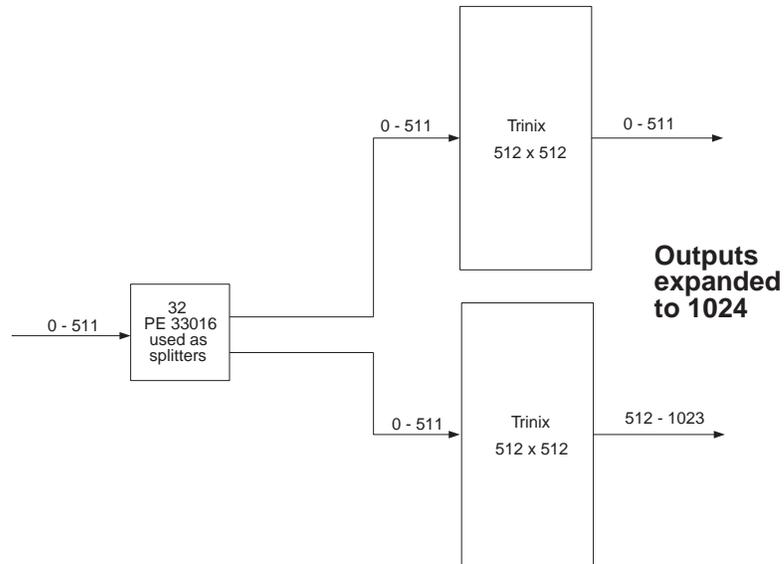
Figure 14.

- 3. Output expansion** requires *input* splitters and *input* gain adjustment. See Figure 14 for an example.

The gain increase is accomplished by closing the rear-panel *Output Expand* DIP switch. This will provide the proper gain increase for all input boards in the chassis.

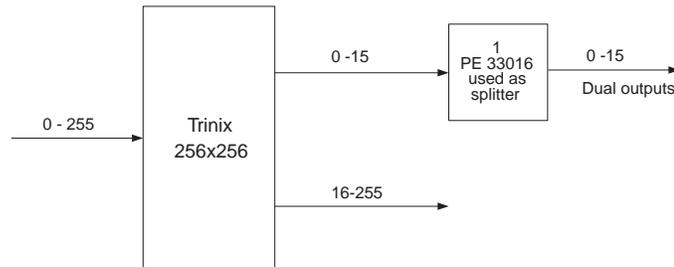
Figure 15.

The PE-33016 Port Expander can be used to provide dual outputs in groups of 16 outputs, while the PE-33008 Port Expander can be used to provide quad outputs in groups of 16 outputs. For example, Figure 15 shows outputs 0-15 with dual outputs and the remainder with single outputs.

In this example:

- For SO-33110/33011 and HO-33110/33011 output boards, the gain for outputs 0-15 is boosted by closing the rear-panel *Input Expand* DIP switch and verifying that the **on-board jumper** for that set of outputs is in the “Expand Enable” position. The location of the boost jumper on these output boards is shown on page 18. The gain for outputs 16-255 must be held at unity by setting the on-board jumpers for that set of outputs to the “Force Normal” position; this overrides the rear-panel DIP switch setting for those outputs.

- For HO-33120/33121 output boards, the gain for outputs 0-15 is boosted by closing the rear-panel *Input Expand* DIP switch and verifying that the **on-board DIP switch** for those outputs is closed. The location of the DIP switches for these boards is shown on page 19. The gain for outputs 16-255 must be held at unity by opening the on-board DIP switches for that set of outputs; this will override the rear-panel DIP switch setting for those outputs.

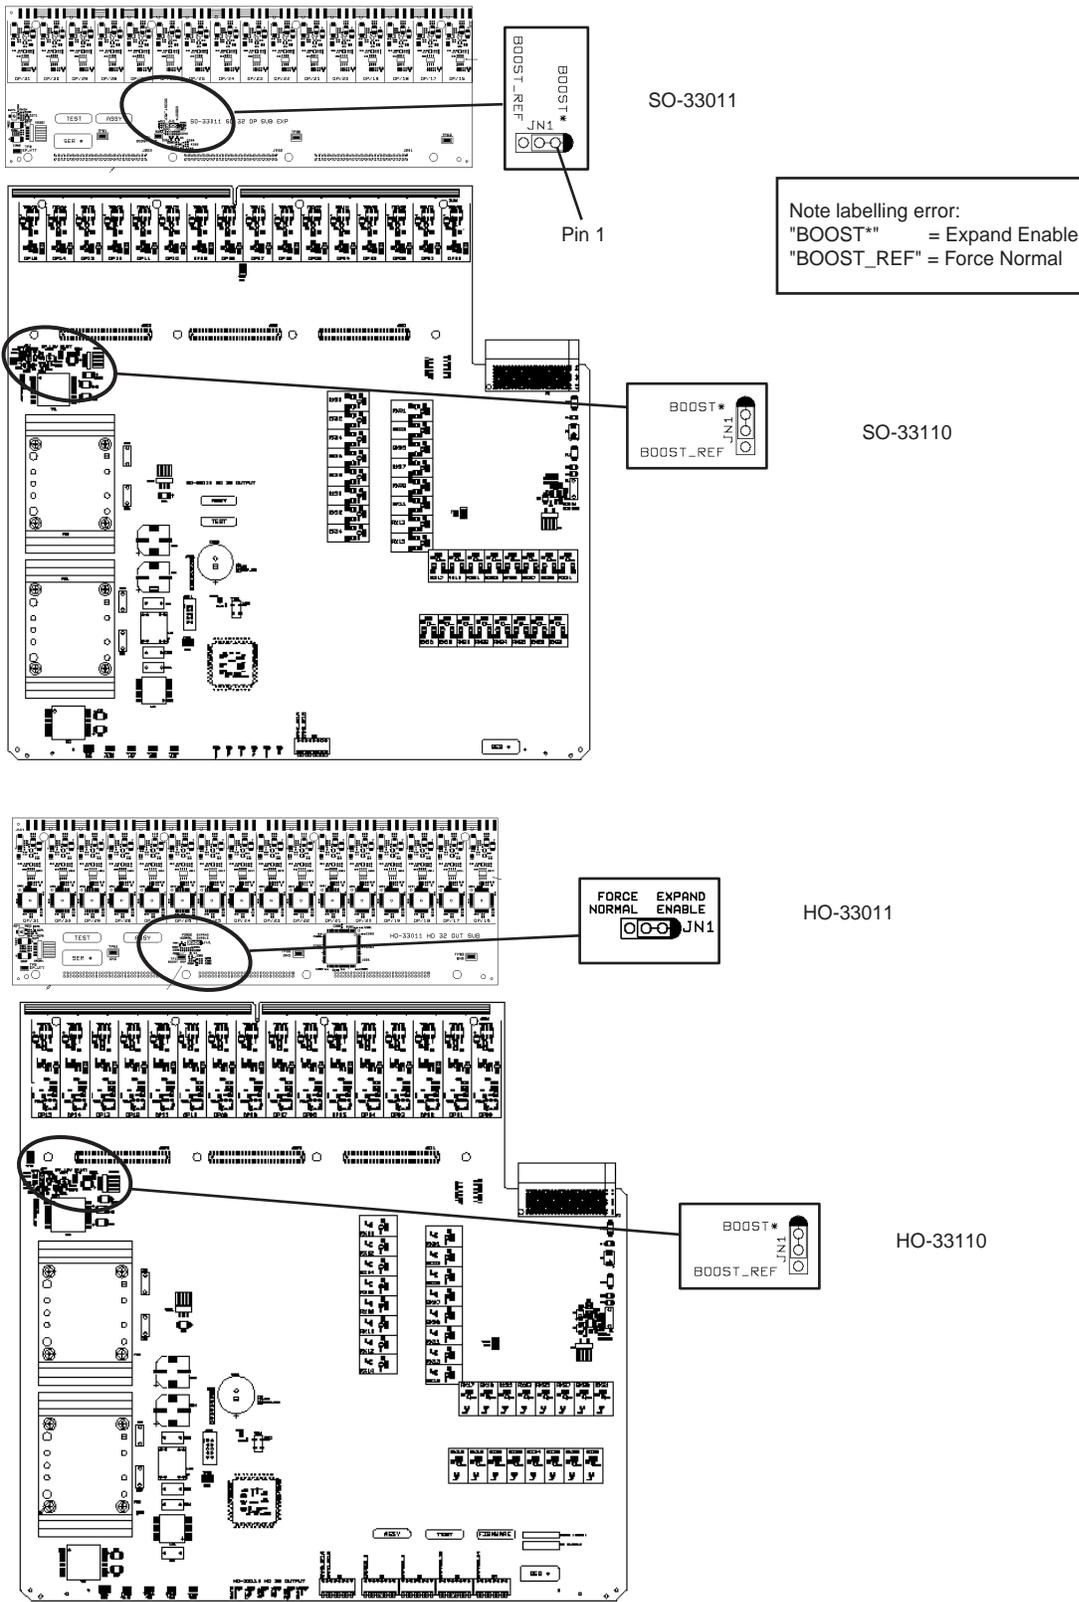
Figure 16. Location of gain jumpers on SO-33110/33011 and HO-33110/33011 output boards.

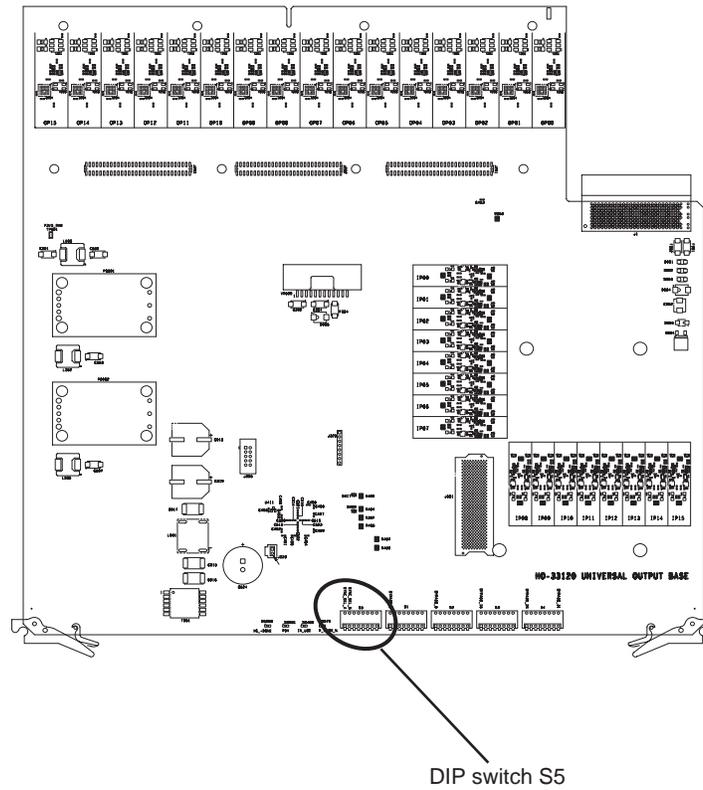
Figure 17. Location of gain switches for HO-33120 Universal Output base board and HO-33121 Universal Output mezzanine board.

Table 1. HO-33120 DIP switch S5 settings.

S5-3 HO-33120 (base board) outputs	S5-4 HO-33121 (mezzanine board) outputs
Expand Enable: Use rear-panel “Input Expand” boost switch setting for these 16 outputs	Closed	Closed
Force Normal: Hold gain at 800 mV (do not boost) these 16 out- puts. This setting over- rides the rear panel switch.	Open	Open
