# Profile XP System Software 4.0.16 Release Notes

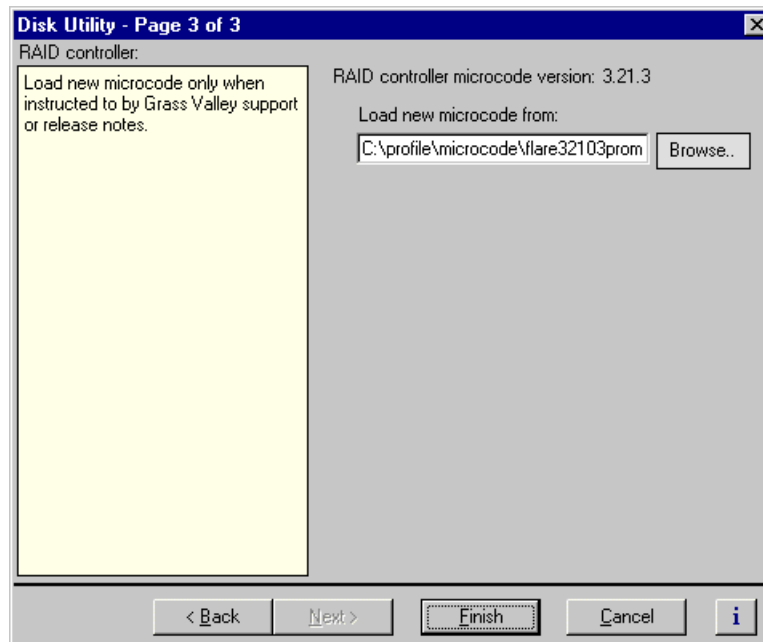
1. Start Configuration Manager and choose **File System**.
2. Click **Next** twice to open the third page, Disk Utility.
3. In the Disk Utility - Page 3 of 3, browse for the latest RAID microcode file in the `c:\Profile\microcode` directory on the system drive. Select the `.bin` file with the highest “flare” or “prom” version number. For example, `flare32104prom202.bin` is more recent than `flare32103prom202.bin` and `flare32103prom203.bin` is more recent than `flare32103prom202.bin`.
4. Click **Finish** and wait for the microcode to load.

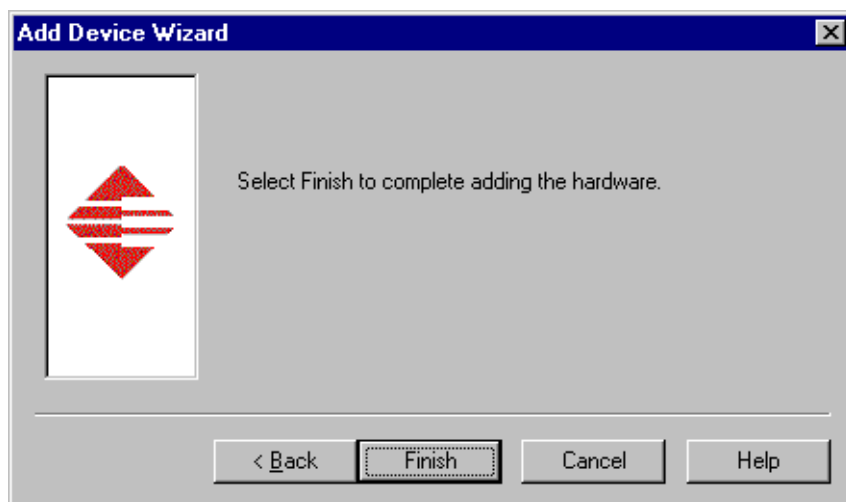
**Figure 6.** Finish the driver installation.

11. Click Finish to close the Add Devices Wizard (see Figure 6) and open the Device Properties dialog box.
