# **8995UPC/DNC/UDX**

**SD/HD UP/DOWN/CROSS CONVERTER**

## **Release Notes**

Software Version 1.2.4

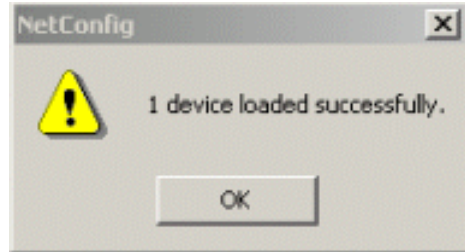
22. If the upload has been successful, a pop-up screen similar to the one shown in Figure 4 will appear and each module should now report its version as 1.2.4 as shown in Figure 5.

Figure 4. Load Successful Popup

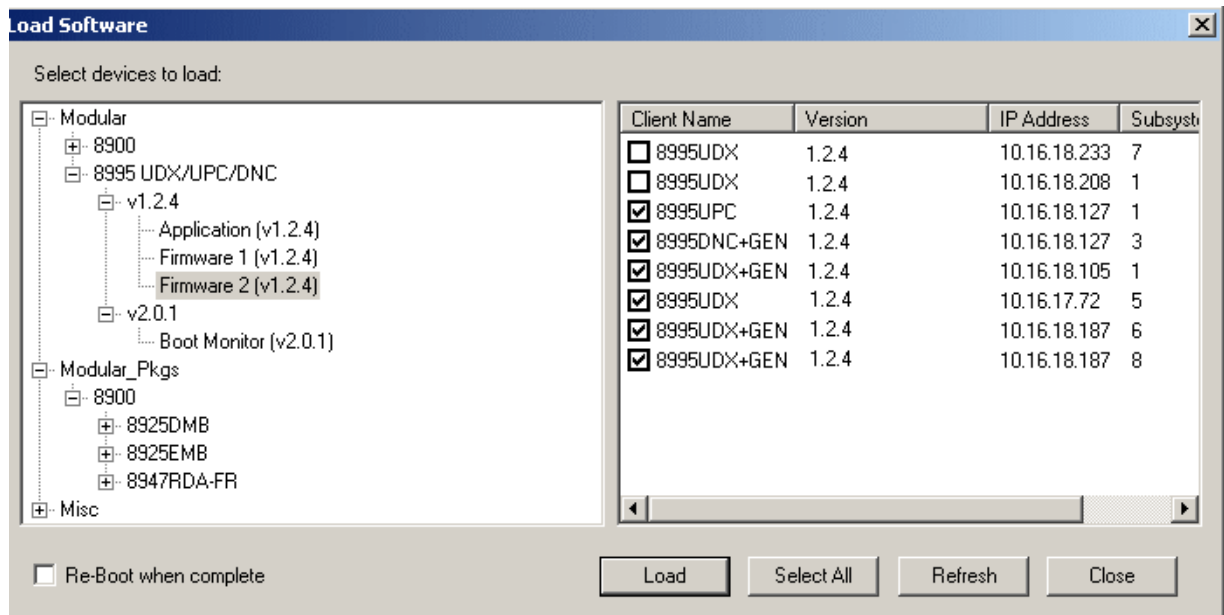
28. Once this has been loaded successfully, select Firmware 2 and load it to all modules in the same manner (Figure 6).
29. Do not re-boot after this step.

Figure 6. Load Firmware 2

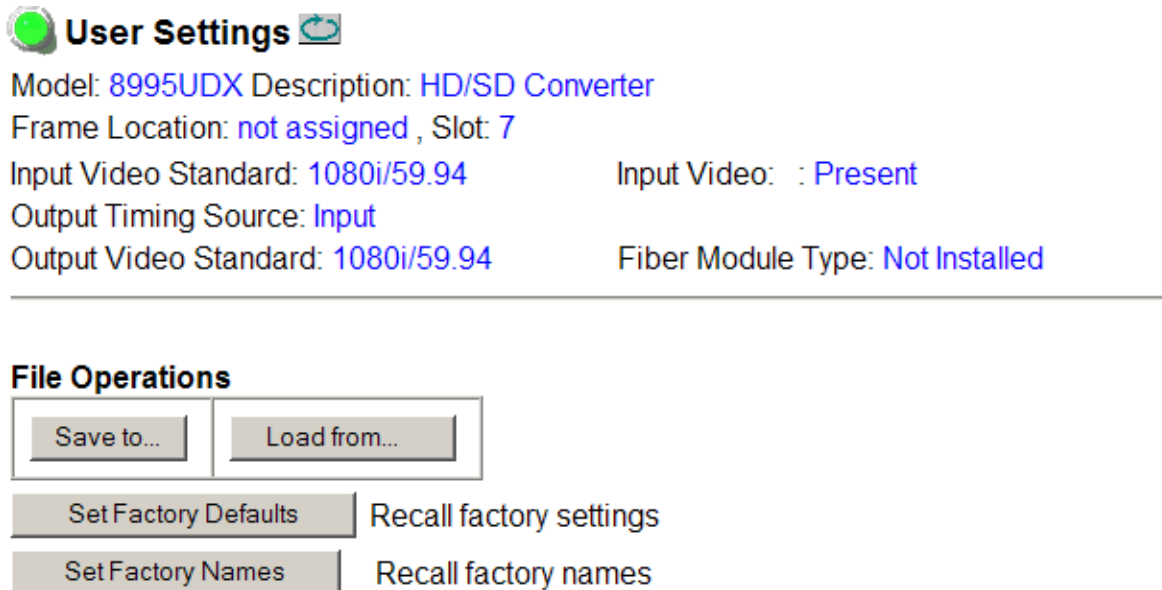
2. It is highly recommended to reset module parameters by linking to the User Settings web page ([Figure 8 on page 15](#)) for each module that has been updated and select the **Set Factory Defaults** and **Set Factory Names** button. This will return the module to the factory default values and update the module with the new parameters for this release.

Figure 7. Recall Factory Settings and Names

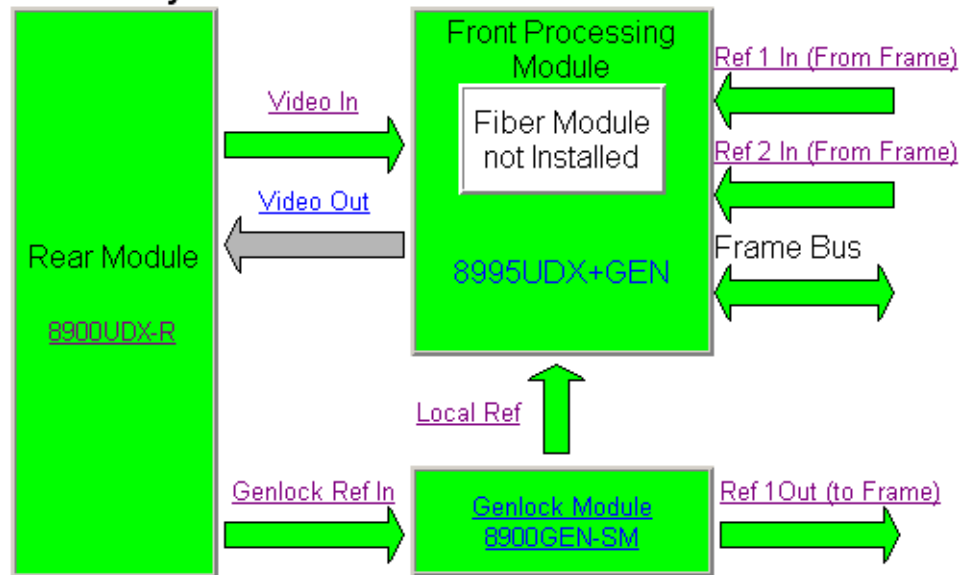
**Module Physical Structure**

Figure 8. 8995 Status Web Page

**Status:**  
 Front Module: [PASS](#)  
 Rear Module: [PASS](#)  
 Genlock Module: [PASS](#)  
 Fiber Module: [EMPTY](#)

Part Number: [771-0503-00](#)  
 Serial Number: [KB07220250](#)  
 Hardware Revision: [00](#)  
 Firmware Image 1 Version: [2.2.6](#)  
 Firmware Image 2 Version: [inactive](#)  
 Firmware Image 3 Version: [inactive](#)  
 Firmware Image 4 Version: [inactive](#)  
 Software Version: [1.2.4](#)  
 Boot Version: [2.0.1](#)  
 Asset Tag:

1. When the software updates have been done, check that the software version for each module on the 8995 Status web page is updated for each module as shown in [Figure 8 on page 15](#).

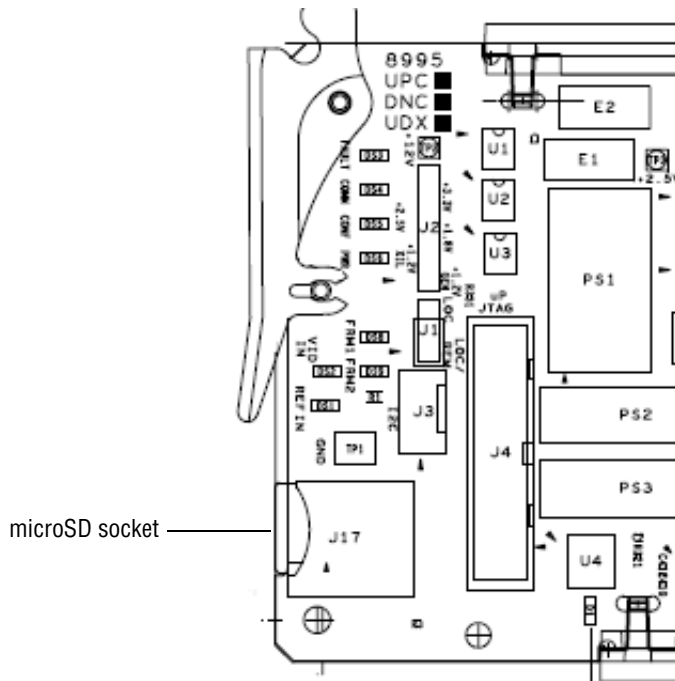
The 8995 modules have been equipped with a microSD socket (J17) located on the front of the module to accept a microSD flash memory card for updating software of the 8995UDX, 8995UPC, and 8995DNC modules (Figure 9). Using this method requires the purchase of microSD hardware by the customer.

Figure 9. MicroSD Socket

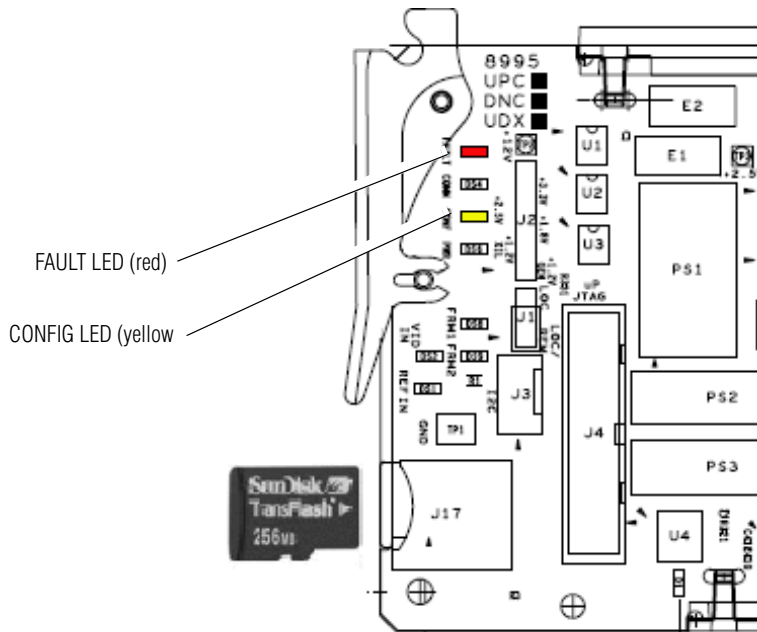
7. Remove the card reader from the PC USB port.
8. Remove the adapter from the card reader.
9. Carefully remove the memory card from the adapter, pull the 8995 module out of the frame and place the memory card into the socket on the front of the module so the label side is to the outside as shown in [Figure 10 on page 18](#).
10. Insert the module back into the frame to reboot and start the update process.

While the boot code is loading the update, the CONFIG LED (shown in [Figure 10](#)) on the module will indicate the progress. If the CONFIG LED is lit, the boot code is currently writing the update to flash.

Figure 10. Insert Memory Card into Module Socket

If the FAULT LED begins flashing, a failure to update has occurred. A failure to update can occur when the memory card cannot be read (larger than 2Gb), no .upd files are found for the module's device class, or multiple files with the same file name are present.
