Profile XP System Software 5.4.6 Release Notes

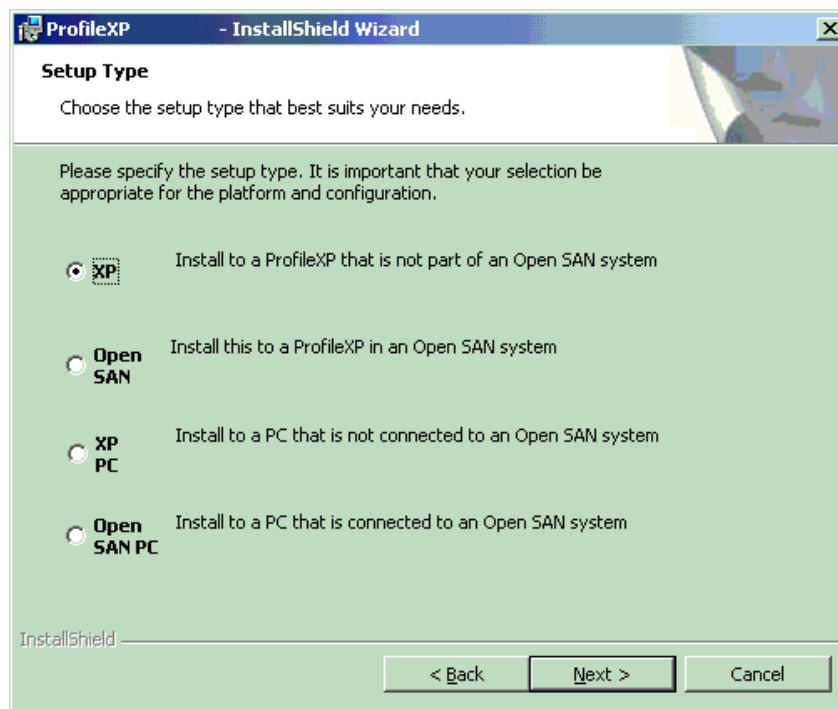
12. When prompted, select the appropriate installation type for your system. Choose Open SAN PC only if you are installing Profile XP System Software on an Open SAN-connected system such as a NewsEdit.

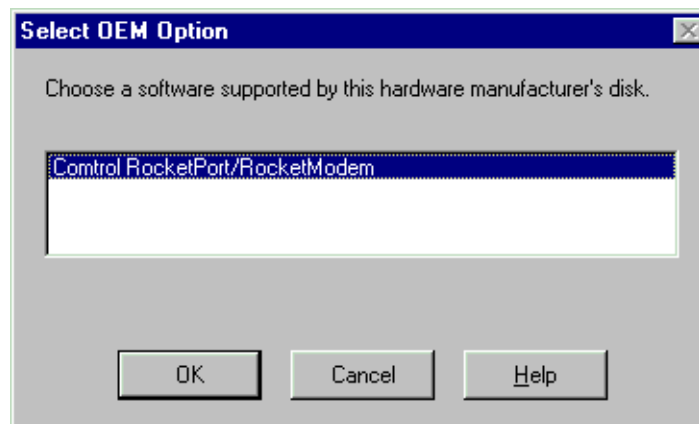
7. The Select OEM Option dialog box appears. Ensure that the Control RocketPort RocketModem is selected, then click **OK**.

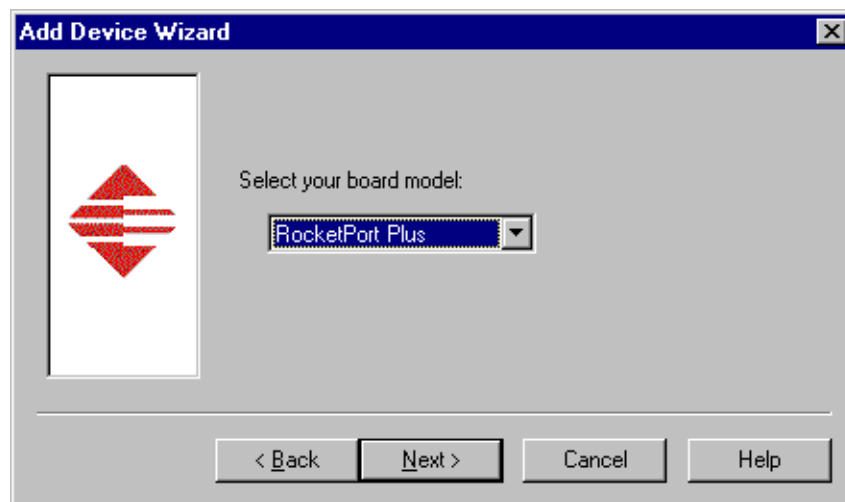
9. Select RocketPort Plus as the board type, then click **Next**.

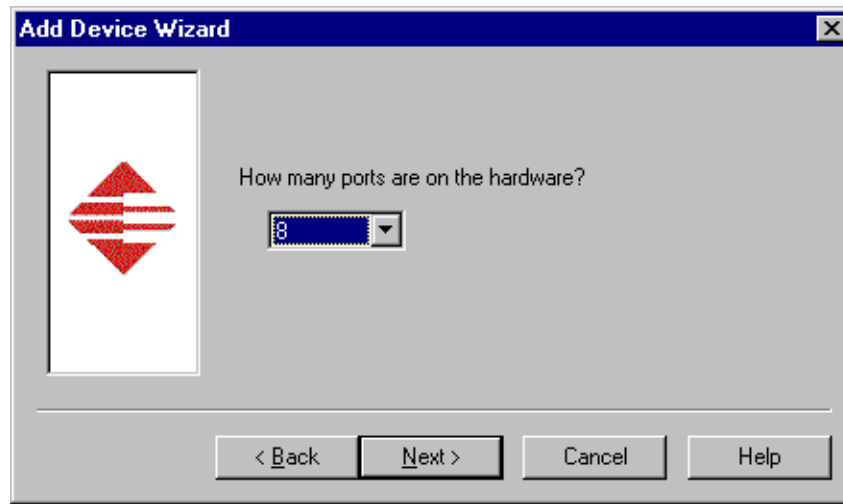
10. Select eight ports on the hardware, then click **Next**.

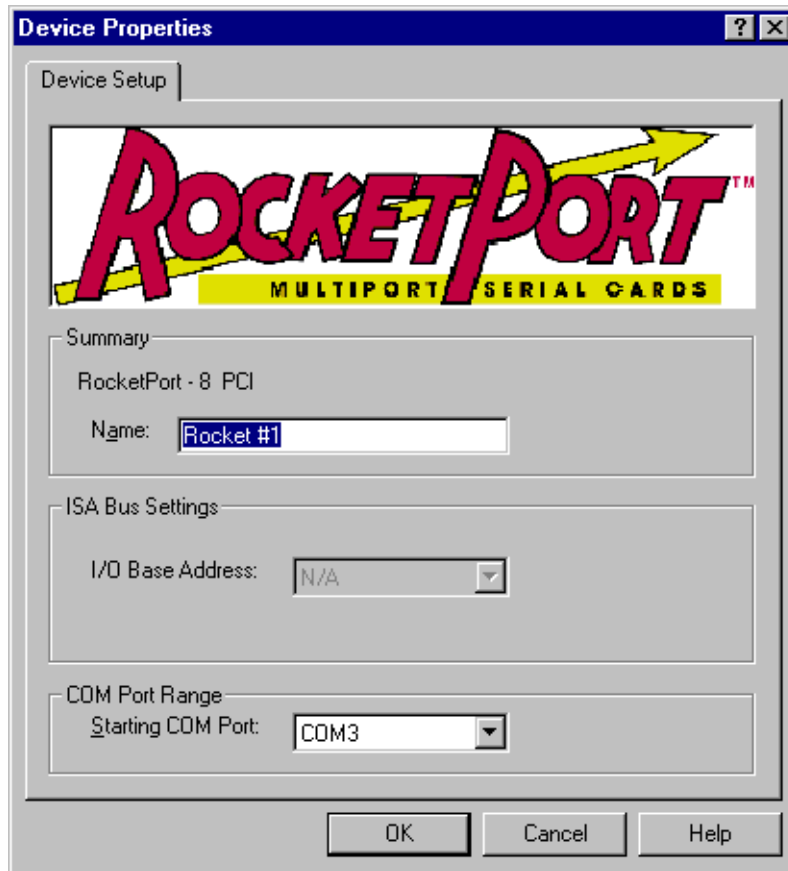
12. Ensure that the Starting COM Port is set to COM3, then click **OK** to close the Device Properties dialog box.

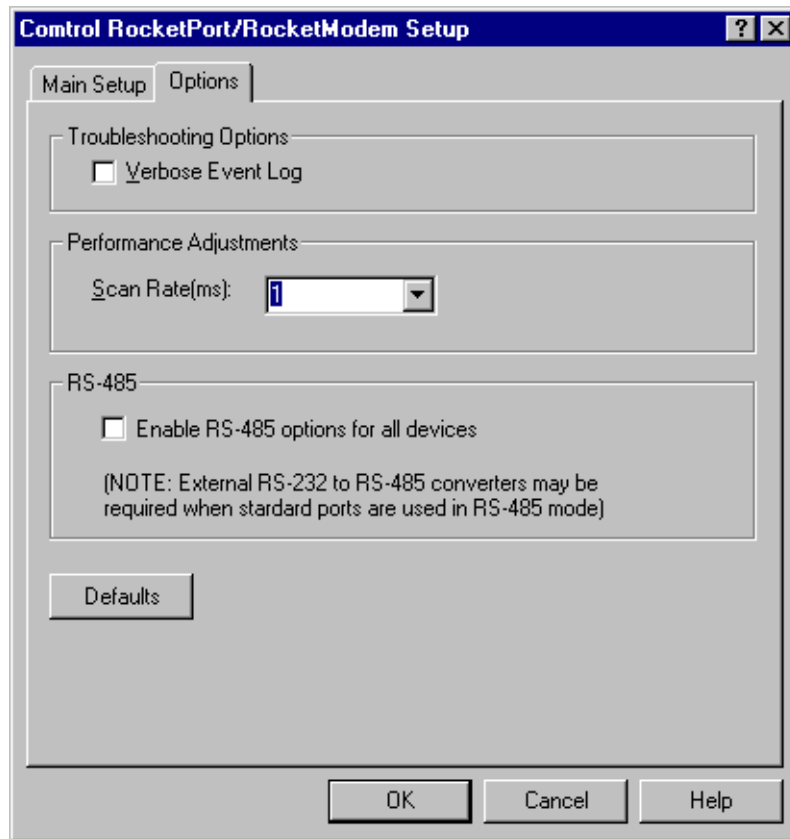
14. In the **Options** tab, set the **Scan Rate(ms)** to 1ms.
